RE: Echelon Building I – Preliminary Structural Evaluation

**Re: Echelon Building No. 1 - 9430 Research Boulevard
Preliminary Engineer's Report Regarding the Physical Condition of the
Soil and Rock Wall Adjacent to the Northeast Side of the Building and
Potential Impact on the Building Foundation**

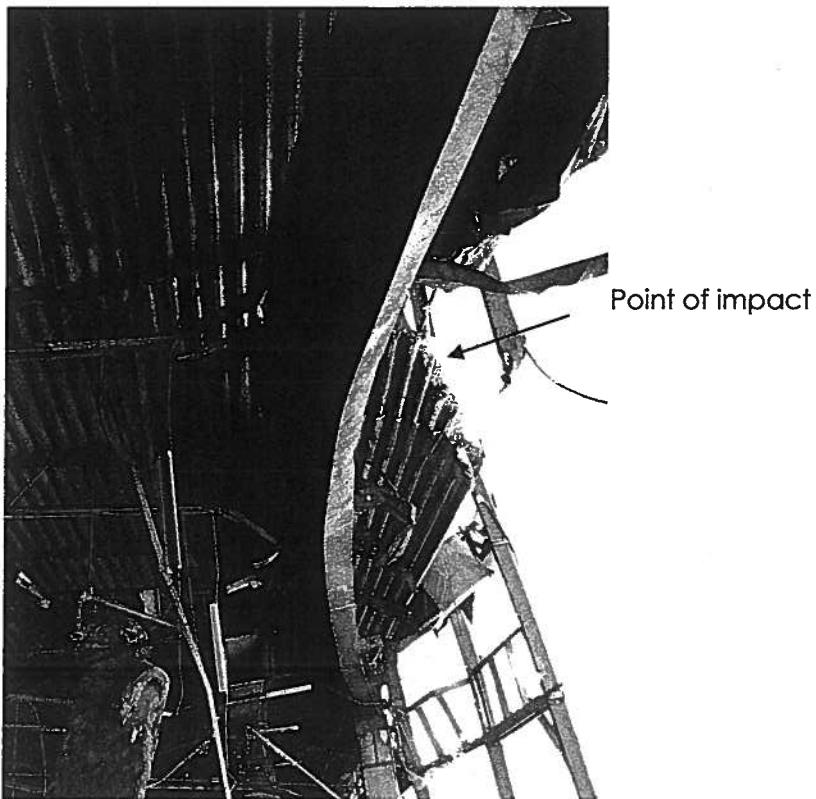
Fig.1

The structure was impacted at the second level floor line immediately adjacent to the frontage road of Hwy. 183. The photo below shows the floor girder bent laterally crushing the bar joists that bear onto the girder. (Fig.1)
